Service News

BULLETIN NO. **E-1239**

RX-V361/RX-V461/RX-V561
RX-V461DAB/RX-V363
HTR-6030/HTR-6040
HTR-6050/HTR-6130

No Power

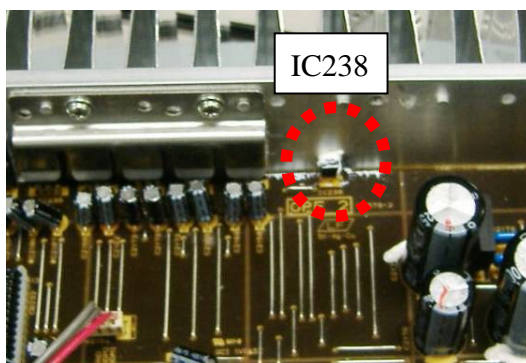
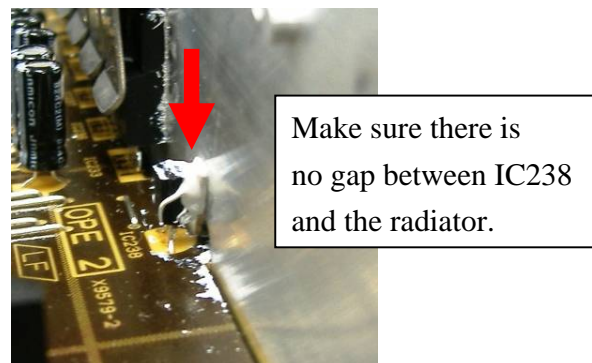
CAUSE: Temperature of the radiator (heat sink) was not monitored correctly due to lack of silicon grease which fills the gap between the radiator and IC238 thermal detector on OPERATION(2)PCB. Due to this lack of thermal contact, even when the temperature exceeds 20 deg.C above the threshold, the AMP power supply relay cannot function properly. This results in the blowing (opening) of the thermal fuse within the power transformer.

SOLUTION: For units with thermal fuse blown power transformers, replace power transformer and apply enough silicon grease between IC238 thermal detector and the radiator as shown below.

Make sure there is
no gap between IC238
and the radiator.
