# Service News

BULLETIN NO. **E-1254**

**RX-V363/HTR-6130**

### No Power

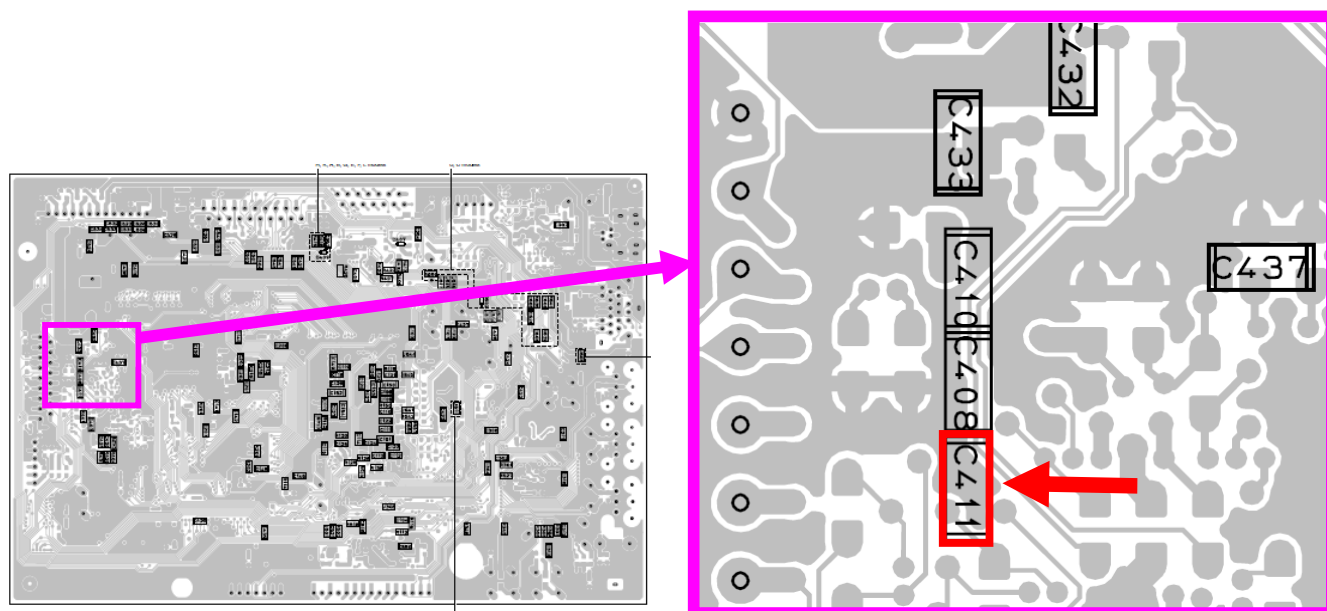
**SYMPTOM:** Doesn't power ON. It is likely to occur under low temperature. Can recover by unplugging and then plugging the AC cable back in.

**CAUSE:** Product lot with serial number "Txxxxx8XZ" have been found that some of them won't power on due to CPU error caused by clock line noise from the unevenness of the A/D converter on the DSP board.

**SOLUTION:** By removing C411 chip capacitor from the DSP board, clock line noise will be reduced and prevent CPU error.

**SERVICING:** Regardless of the symptom, check and remove C411 from all units sent in for service.
