## Part 5 - Antenna Construction

### Tower Base Construction

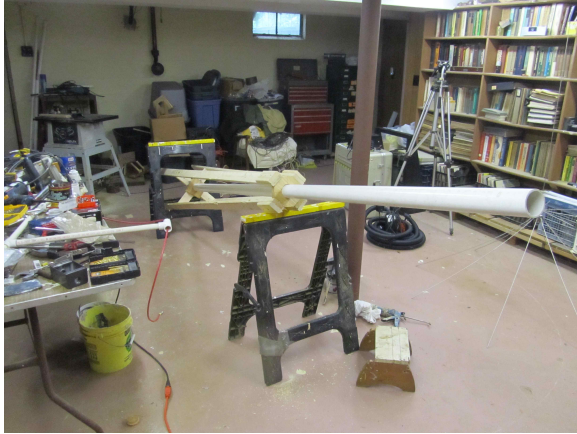
(Pic left) A four-legged base constructed of 1x4 inch construction lumber supports a 10 foot section of Schedule 40 PVC pipe. The construction of the loop antenna is 'standardized' in that all are mounted on a 10 foot section of 1 1/4 inch Schedule 40 PVC pipe. With appropriately spaced 1 1/4 inch couplings joining additional sections to the antenna pipe, this antenna pipe can be snug-fitted within the 2 inch outer pipe allowing easy rotation. The length of the additional sections are chosen to position the center of all loops 20 feet above ground level.

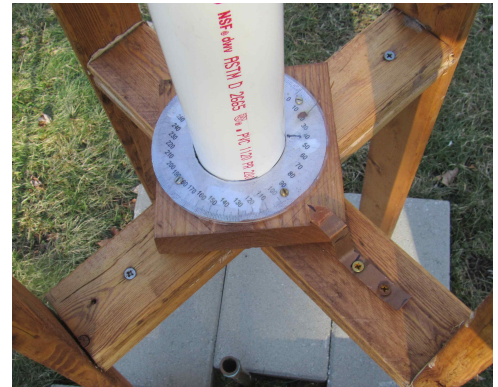
(Pic above) The base of the outer pipe, with a compass rose attached, is supported on a wooden plate which is affixed to a 3 inch 'Lazy Susan'. This assembly permits the antenna to be easily rotated. (The 'Lazy Susan' is not in view in this picture but can be seen in the version at my TN QTH pictured next.)

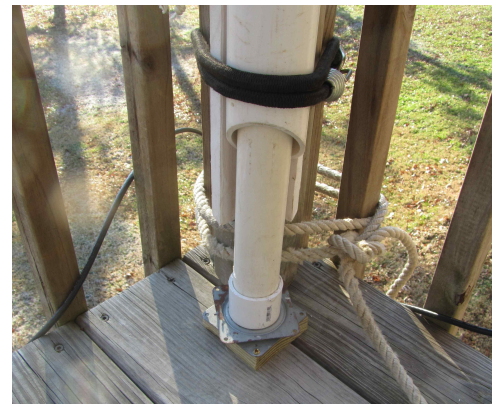
(Pic right) View of the TN three inch 'Lazy Susan' awaiting the attachment of a compass rose. The 'Lazy Susan', being of metal construction with steel ball bearings, when exposed to the elements for extended periods is prone to rust. However for both of the units in NJ and TN after almost a year in use and through all kinds of weather, it has been found that the corrosion can be controlled by liberal periodic application of WD40 or light machine oil.

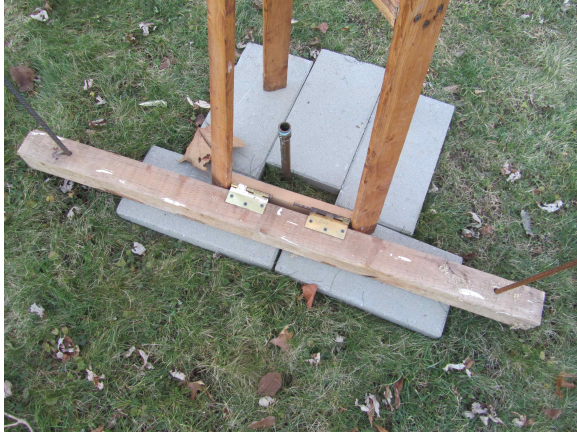
(Pic left) Hinged base of tower permits it to be tilted over to load or remove an antenna by withdrawing or inserting the antenna pipe into the 2 inch diameter outer pipe.

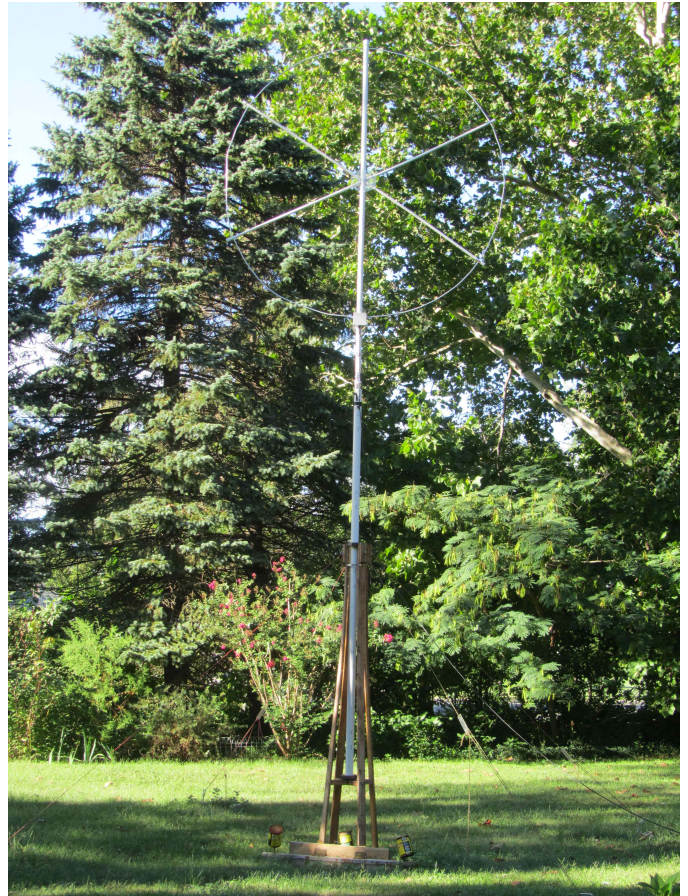
(Pic below) Tower mount with 8 ft Loop installed - NJ QTH.

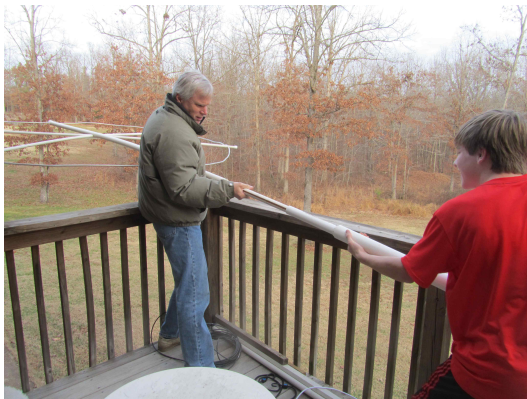
(Pic below) Son and Grandson inserting the 8 foot Loop's antenna pipe into the outer pipe. TN QTH.

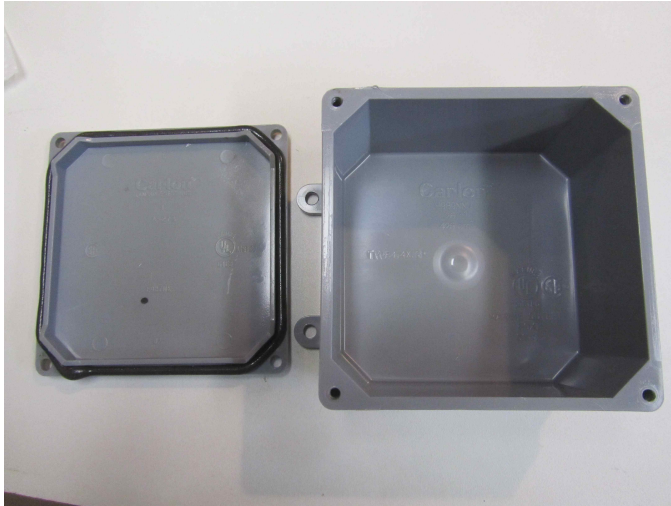
(Pic left) Carlon Marine Waterproof Box, type E998NNJ, 4x4x2 inches used for all preamp mounting in this project. The o-ring seal was found to be a particularly attractive feature. Purchased a local construction supply center.

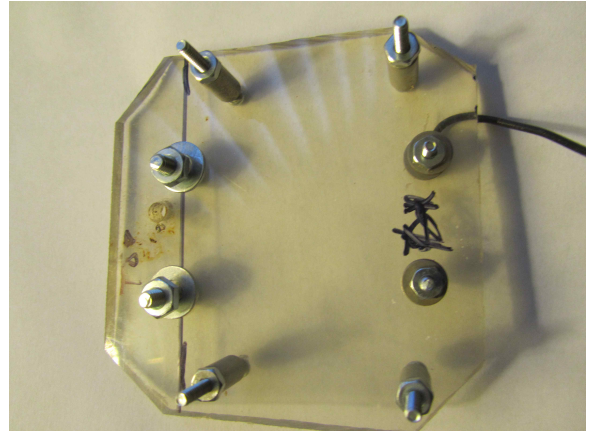
(Pic right) The preamp is held in place by being affixed to a Plexiglas slab which was dimensioned to fit within the box. This particular slab was used to mount the connection to a wire loop, the connection being made to the two screw terminals on the left in the picture. The screw terminals on the right are for the V+ connection. The preamp was held in place on the four screws with standoffs at the top and bottom of the slab.

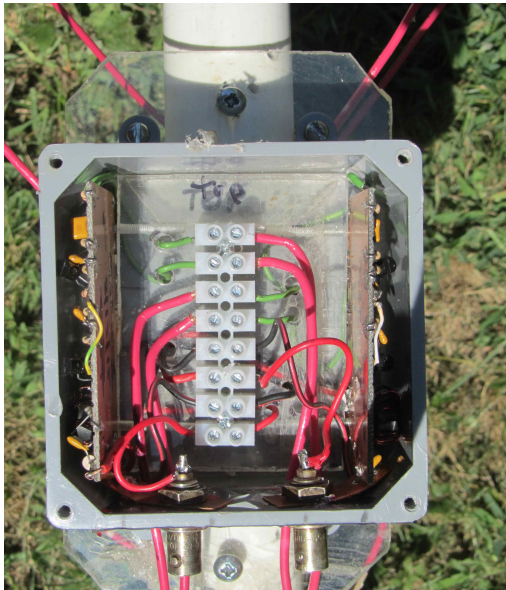
(Pic left) A pair of preamps held in place along the left and right sides of the Carlon box by screws into threaded holes in the Plexiglas slab.

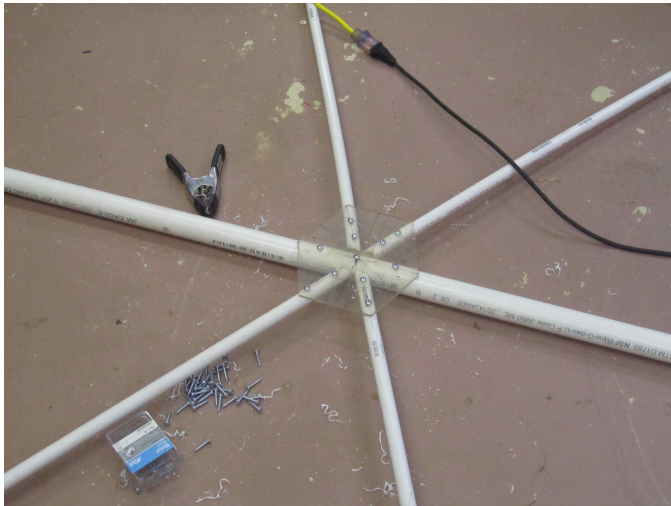
(Pic left) On loops requiring spoke support to maintain structural integrity, 1/4 inch thick Plexiglas gusset plates are used to lock the spokes to the PVC antenna pole. A short section of a 1 inch diameter wooden dowel is positioned inside the antenna pole directly beneath the gusset plate to strengthen the screw hold.

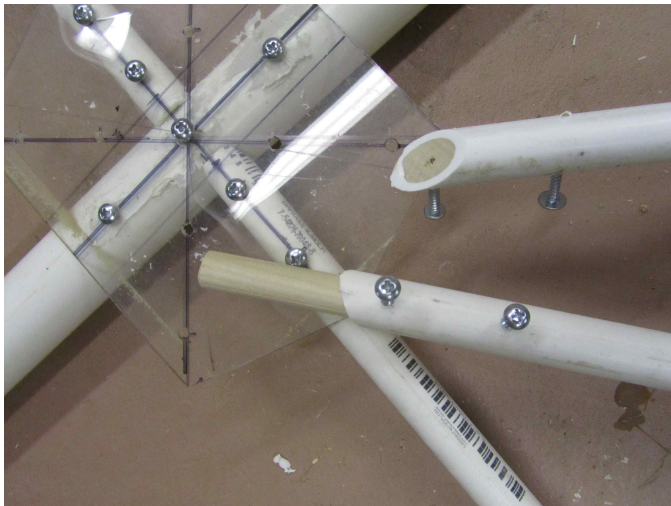
(Pic left) Likewise, and for the same reason, short sections of 1/2 inch diameter wooden dowels are inserted in the spokes where they connect to the gusset plate. Of the two unattached spokes seen in this picture, the lower one has the dowel partially removed for viewing.
